Bioengineering as a Tool for Restoring Ecological Integrity to the Carson River

*by Kevin L. Piper, J. Chris Hoag, Hollis H. Allen,
Gail Durham, J. Craig Fischenich, and Robert O. Anderson*

PURPOSE: This technical note describes a case study involving the following: (a) use of bioengineering (a combination of vegetation and engineered structures and materials) and rock structures to restore an eroded bank of the Carson River, Nevada, and (b) restoration of ecological amenities that existed prior to disturbances by man and a major flood event.

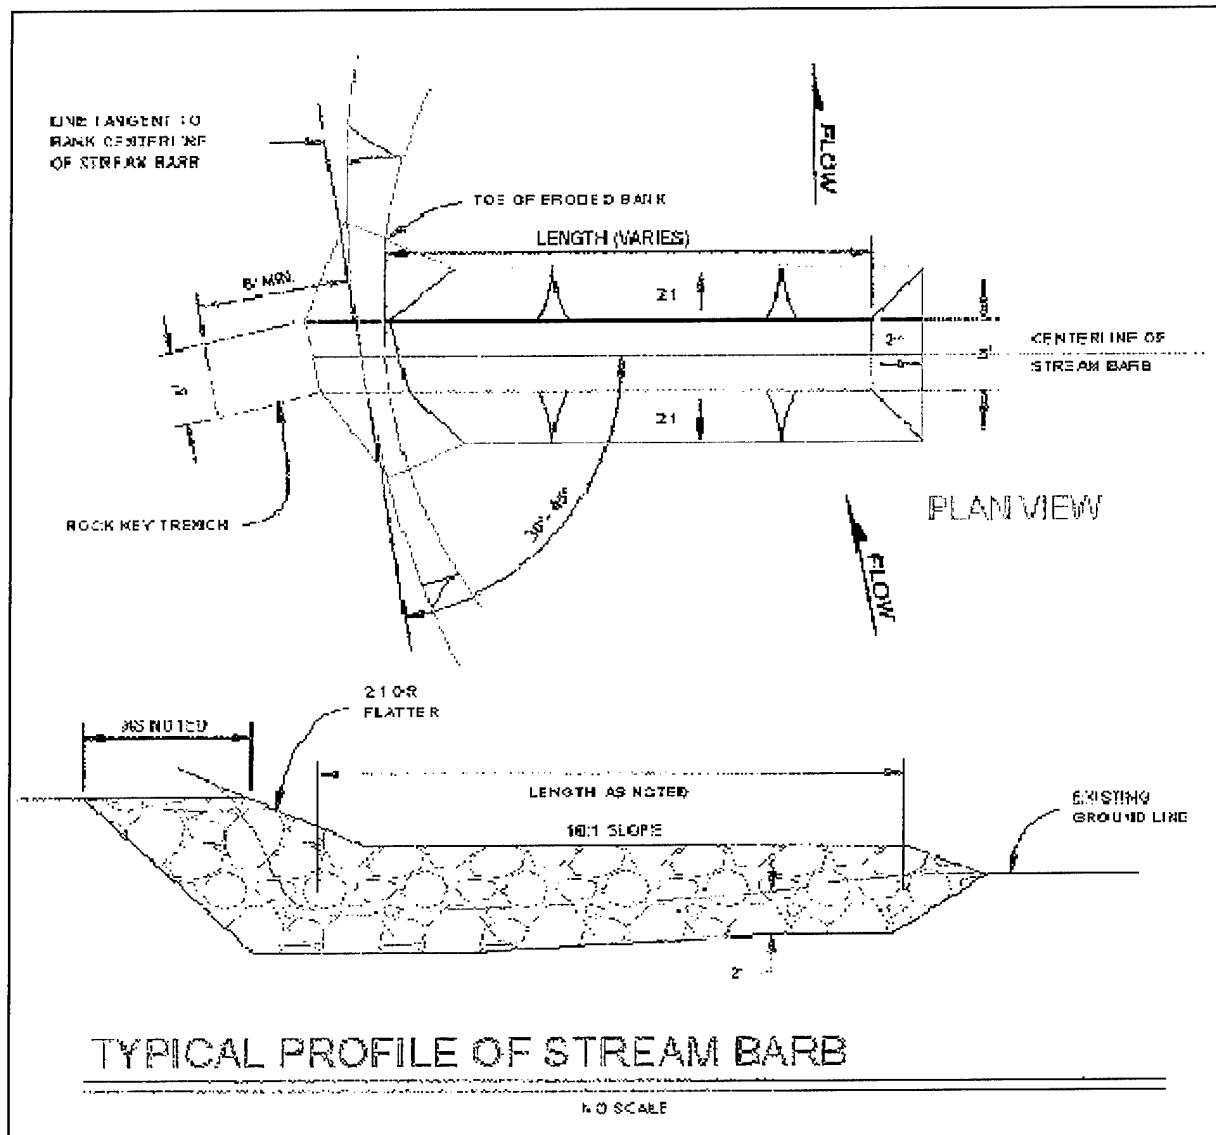
Figure 4. Plan and profile views of stream barb

The stream barbs were pointed upstream; specifically, their center line was positioned 30 to 45 deg from a line tangent to the streambank (Figure 4). Their slope was 10H:1V from the top to the toe and they had at least an 8-ft (2.4-m) rock refusal root extending into the bank. Note that the toe of the barb was keyed into the bed of the river for scour protection. Side slopes were 2H:1V. Such a configuration allowed water to be deflected away from the eroded bank at all water levels and also allowed sediment to accumulate behind the barbs.
